FLOOD PLAIN INFORMATION
WEST BRANCH ROCKY RIVER **(4)**
CUYAHOGA AND LORAIN
COUNTIES
OHIO
LEVEL

PREPARED FOR
OHIO DEPARTMENT OF NATURAL RESOURCES
DIVISION OF WATER
REGIONAL PLANNING COMMISSION, CUYAHOGA COUNTY
LORAIN COUNTY REGIONAL PLANNING COMMISSION
BY

CORPS OF ENGINEERS, U.S. ARMY
BUFFALO DISTRICT
FEBRUARY 1971

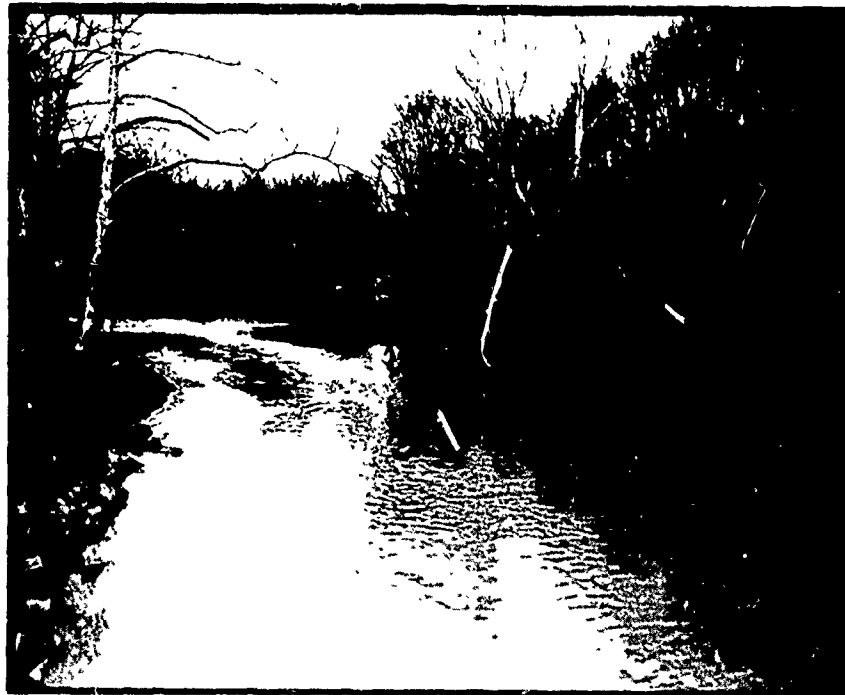
Figure 1 - Looking upstream at East Branch of Rocky River from atop Cedar Point Road bridge, North Olmsted, Ohio.

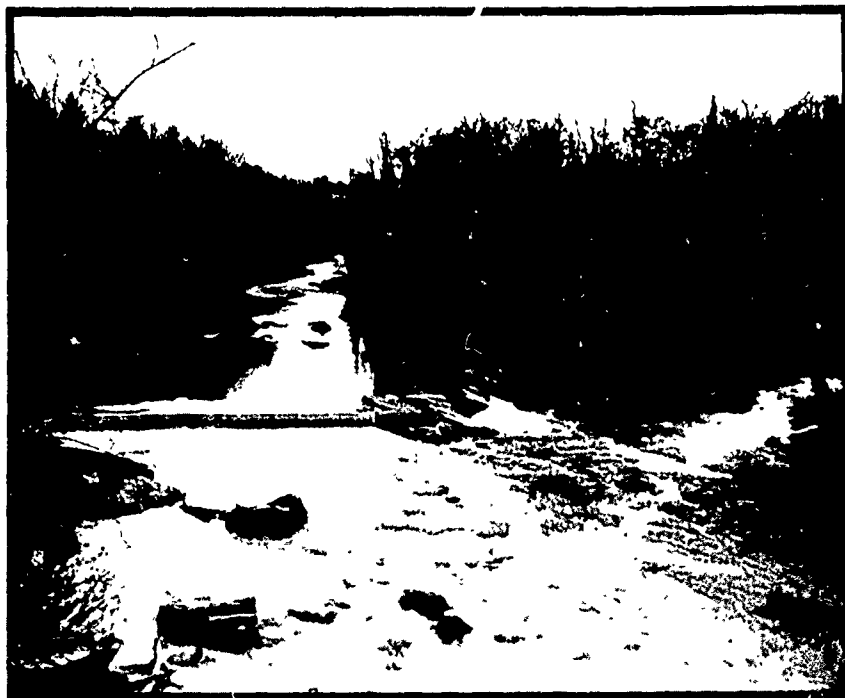
Figure 3 - Looking upstream from atop Water Street bridge, Olmsted Falls, Ohio, stream mile 15.6. Plum Creek is in background.

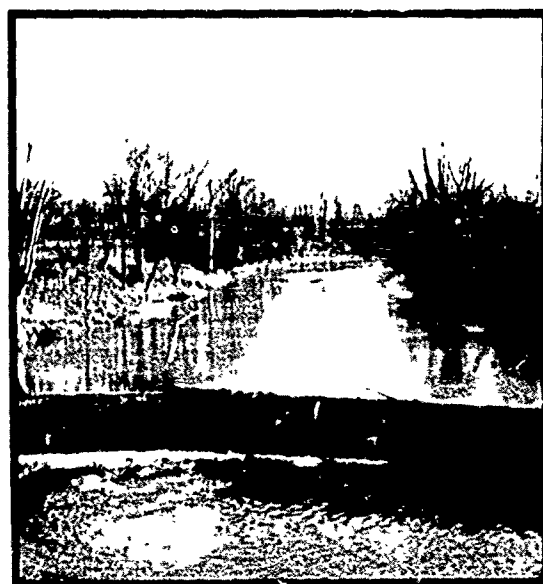
Figure 4 - Looking upstream at dam from atop Sprague Road bridge, Columbia, Ohio, stream mile 17.9.

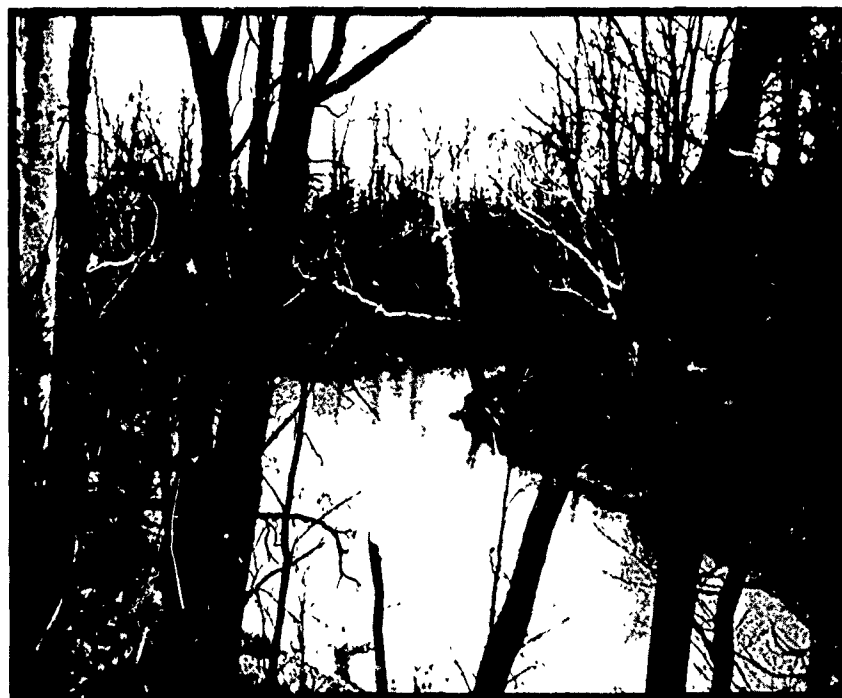
Figure 5 - Looking downstream from left bank at stream mile 19.8, Columbia, Ohio. (Note meandering stream).

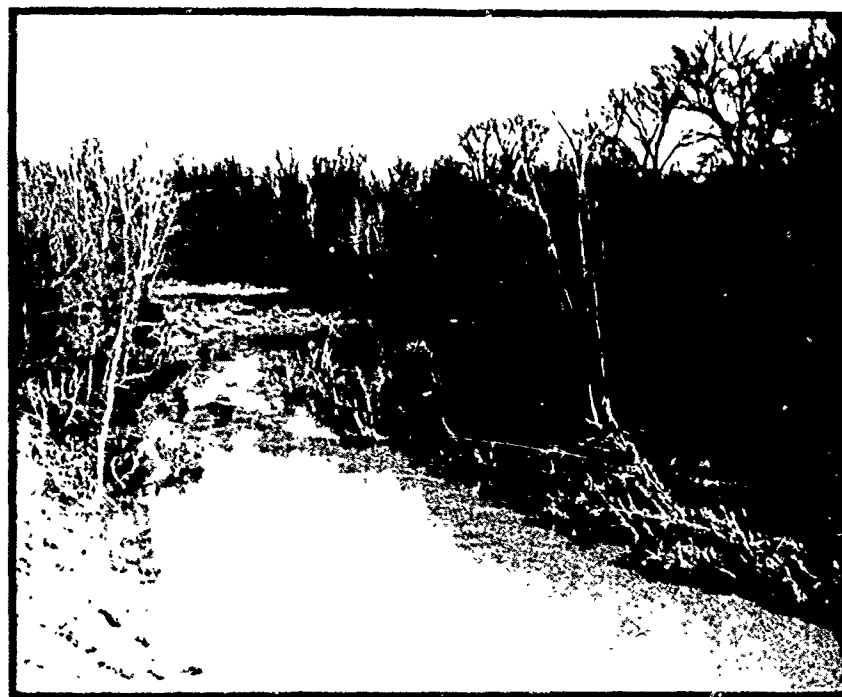
Figure 6 - Looking downstream from atop Royalton Road bridge, Columbia, Ohio, stream mile 21.9.

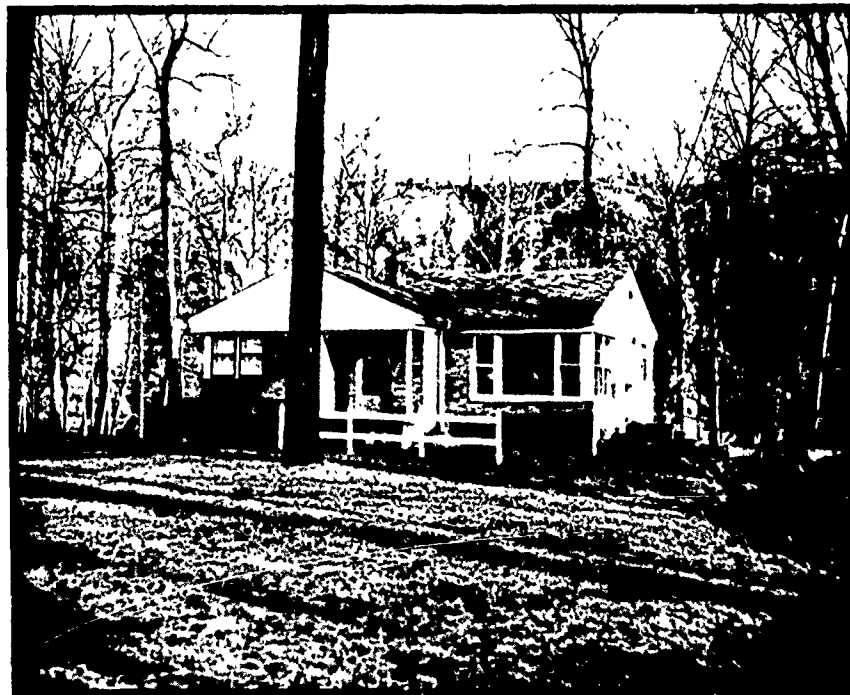
Figure 8 - Typical residence along Rainbow Drive, stream mile 13.0. The January 1959 flood inundated Rainbow Drive.

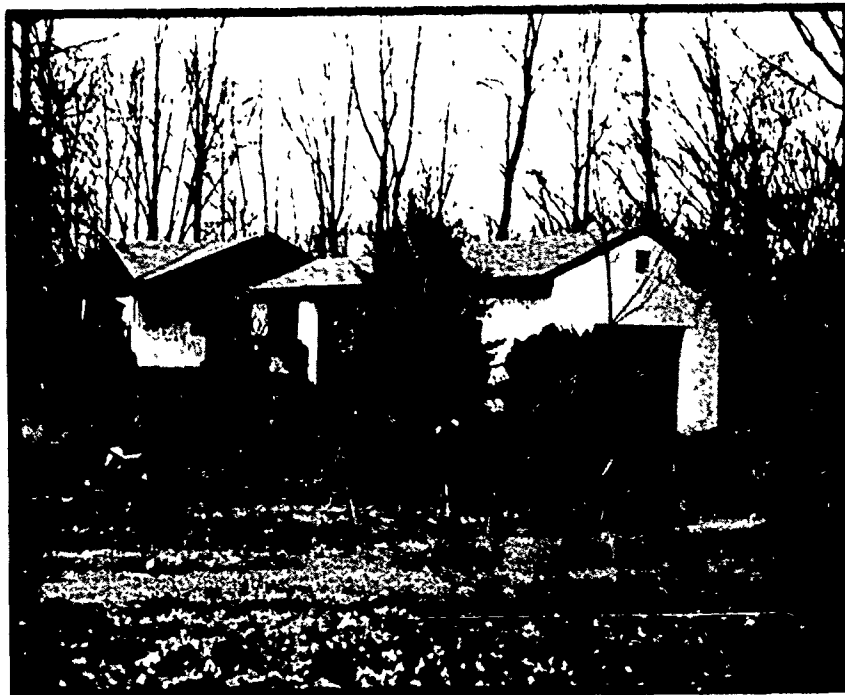
Figure 9 - Typical residence along Metropolitan Drive in village of Olmsted Falls, stream mile 16.2. The Standard Project Flood would affect some residences along Metropolitan Drive.

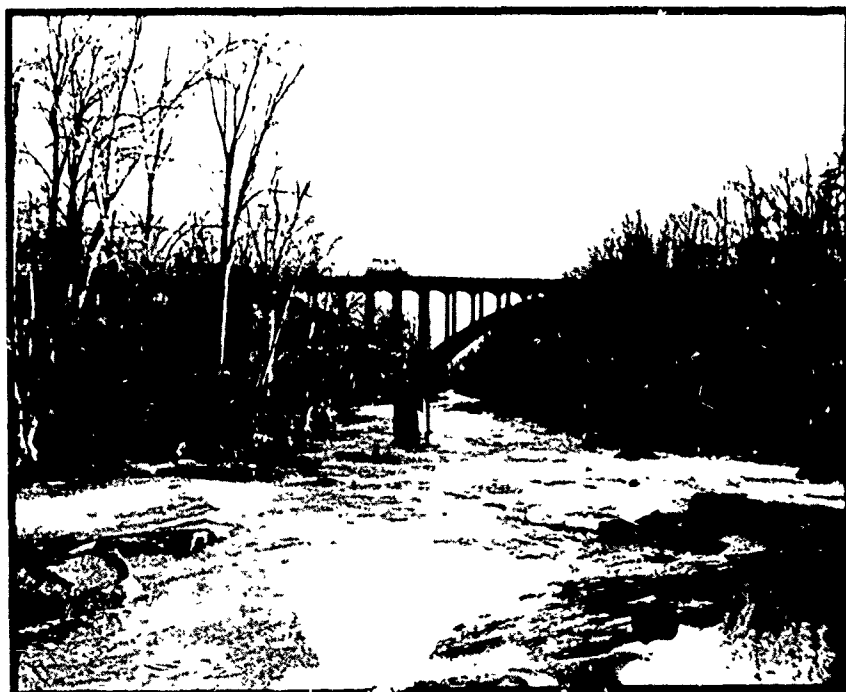
Figure 17 - Upstream face of Water Street bridge,
stream mile 15.5

OBSTRUCTIONS TO FLOOD FLOWS - Inadequate bridge areas, abandoned dams, encroachments, and fills are some of the obstructions to flood flows. Other serious obstructions are bends in the stream, irregularity of channel section, and heavy brush, weeds, and large trees growing on the channel banks and extending into the stream. Figures 20 through 22 show obstructions which tend to reduce floodway capacity and increase river stages.

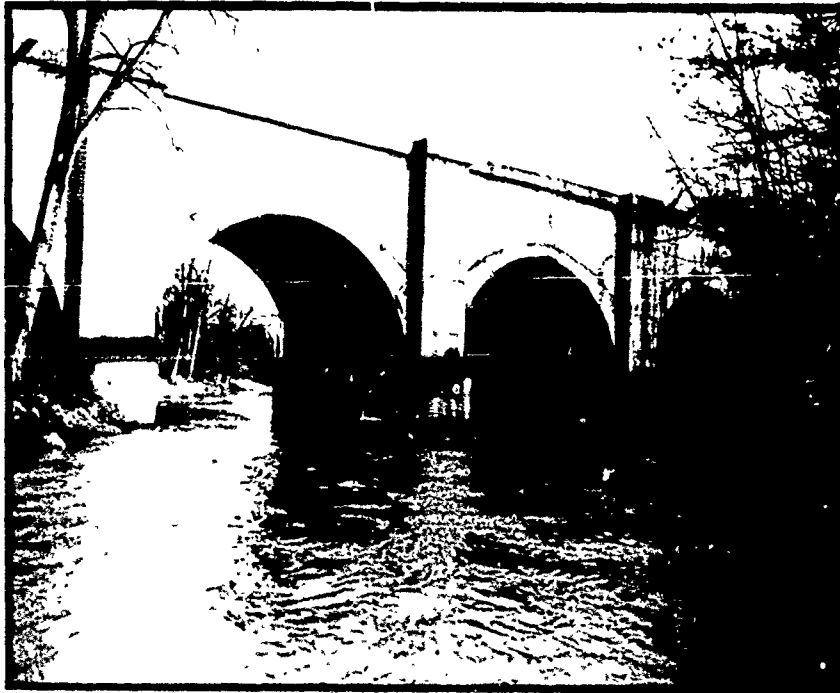
Figure 20 - Upstream face of Penn Central Transportation Company bridge, stream mile 16.9. Note skew of bridge.

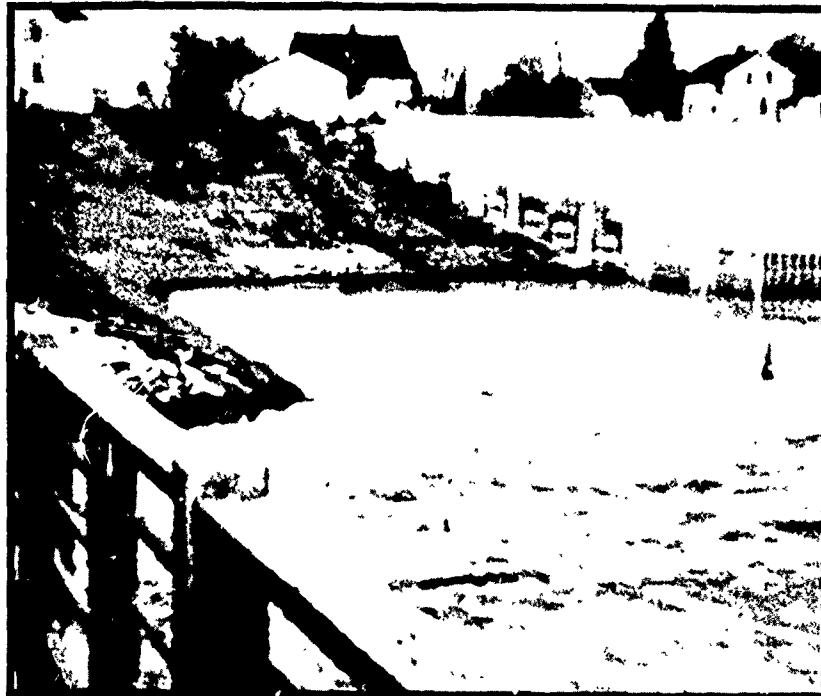
Figure 23 - Flooding conditions downstream of Sprague Road bridge. Photo taken in January 1959 by Miss Bernice Lusk.

Figures 23 and 24 show flooding conditions in January 1959 and February 1959 in the study area.

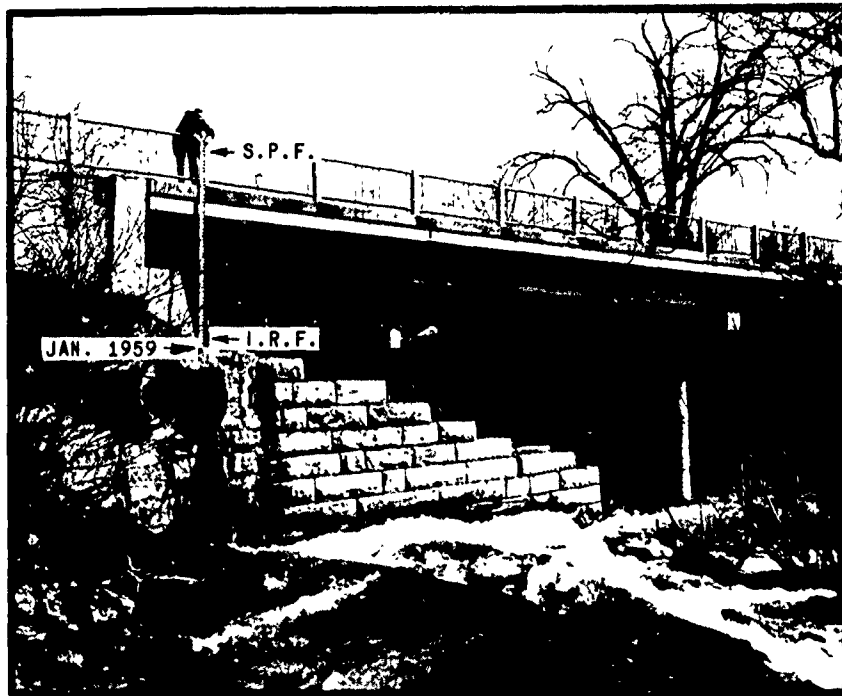
Figure 30 - Arrows indicate the heights of the Standard Project, Intermediate Regional and January 1959 floods at upstream side of Sprague Road bridge, stream mile 17.9.

The approximate heights that would be reached within the flood plain covered by this report by the Standard Project Flood, the Intermediate Regional Flood and the 1959 flood are shown in figures 26 through 31.
